Your Inspection Report

1371 Elderberry Circle
Coeur d'Alene, ID 83815

INSPECTION DATE:
Monday, April 30, 2018

RE: Report No. 1219
1371 Elderberry Circle
Coeur d'Alene, ID
83815

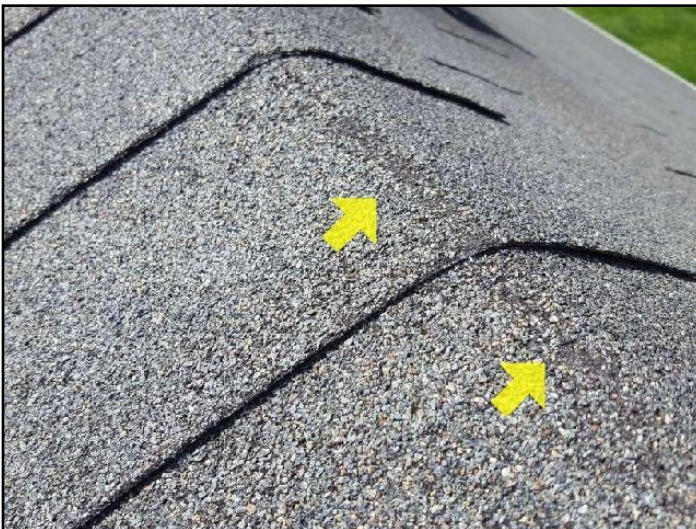
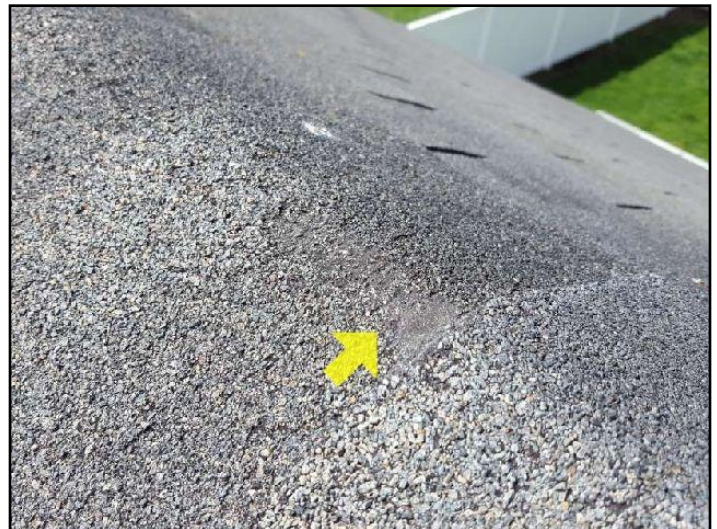
1. **Condition:** • [Granule loss](#)

Granule loss

Granule loss on ridge

Task: Replace

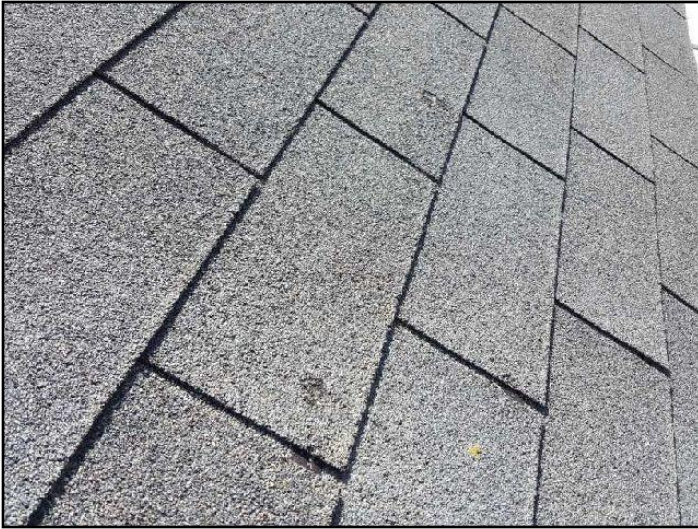
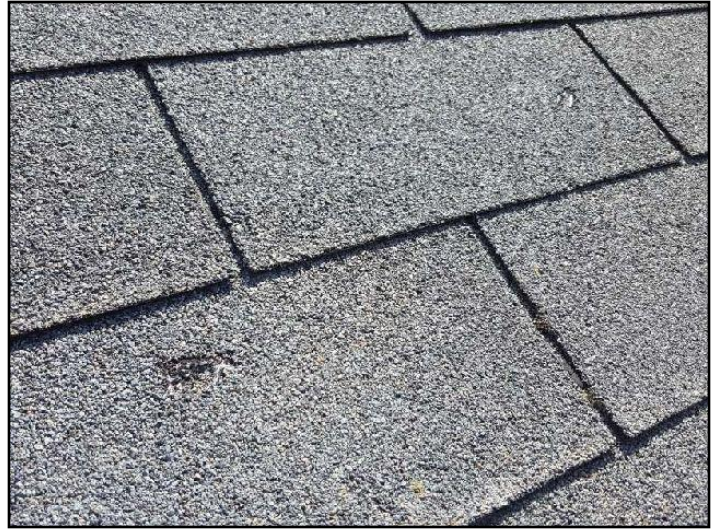
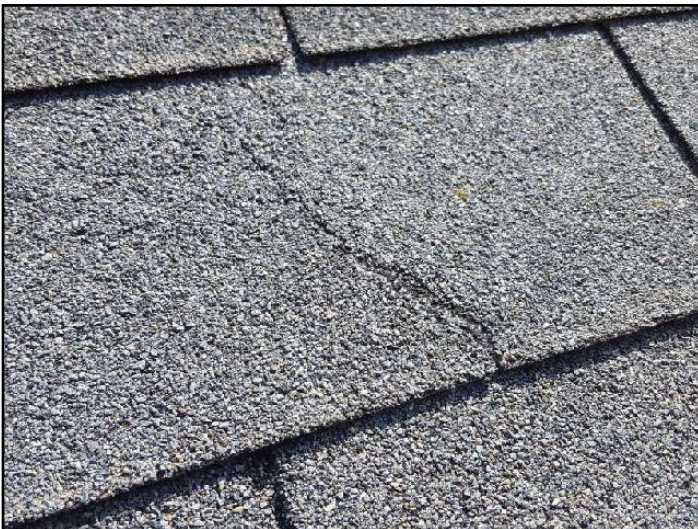
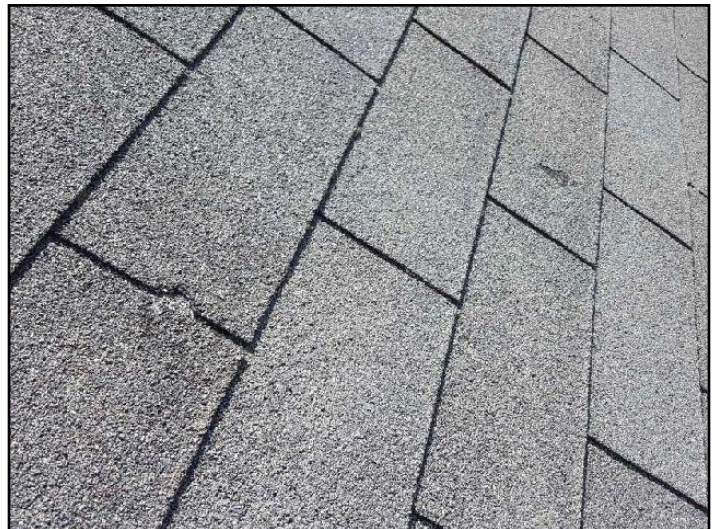
2. Condition: • [Damage](#)

Coverage appears in tact due to layering of the shingles.

Damage

Task: Repair

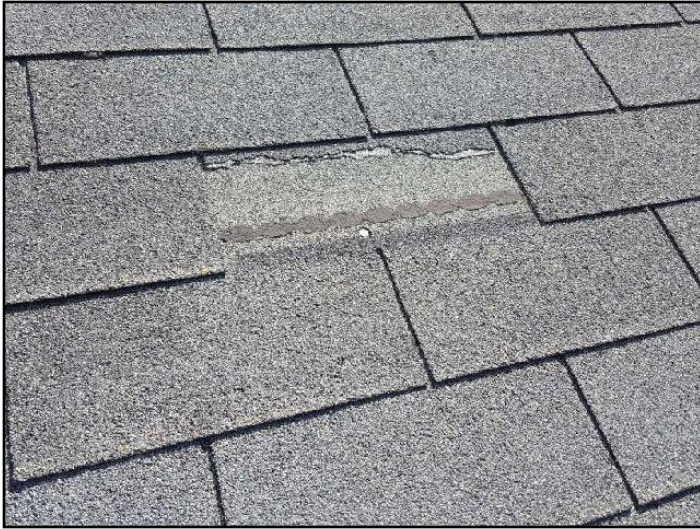
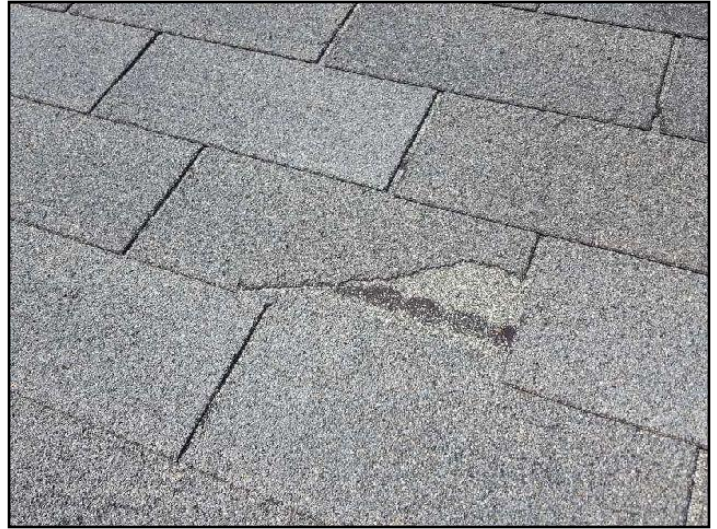
3. Condition: • [Missing, loose or torn](#)

Missing shingle tab

Torn shingle

Task: Repair

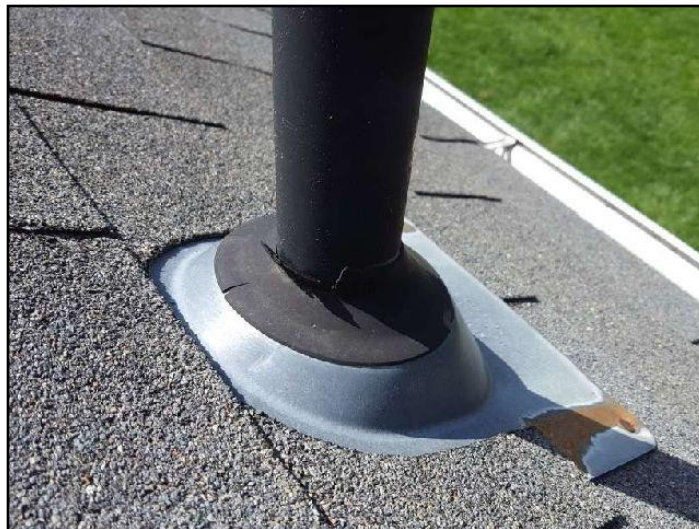
4. Condition: • [Damage](#)

Damaged pipe/stack flashing

Task: Repair

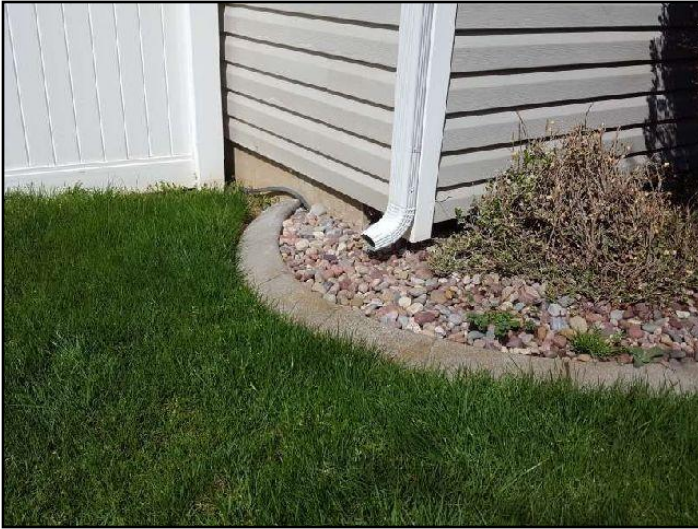
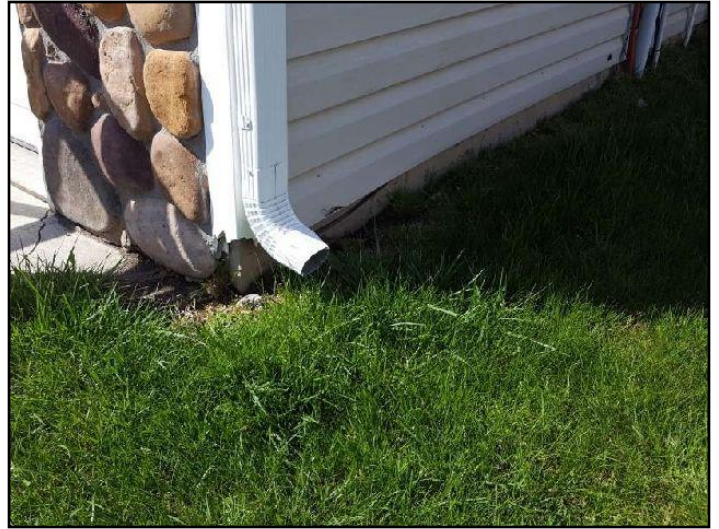
5. Condition: • [Discharge too close to building](#)

Discharge too close to building

Task: Extend downspouts

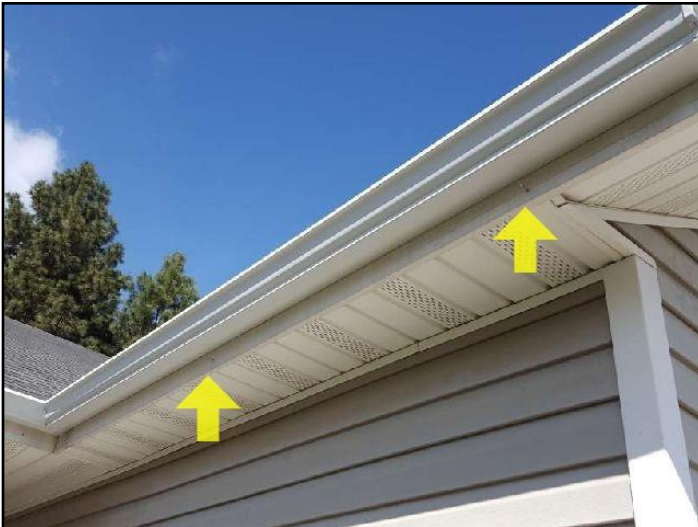
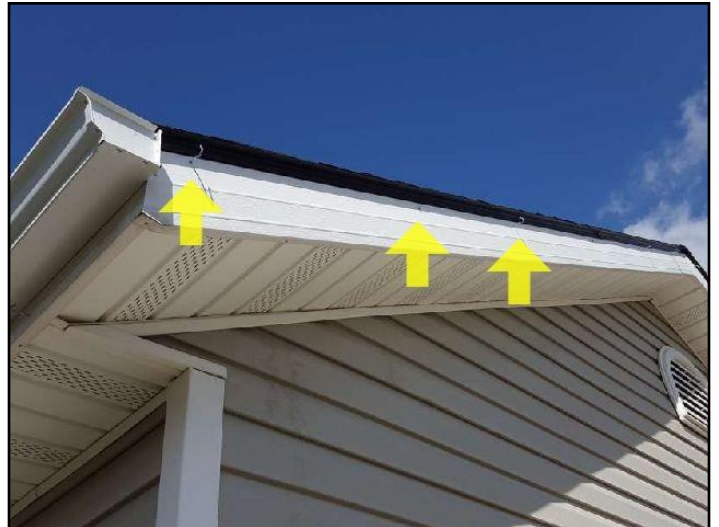
6. Condition: • [Damage](#)

Hooks screwed into fascia have damaged metal trim on fascia

Hooks and holes in fascia

Task: Remove hooks; apply sealant on holes

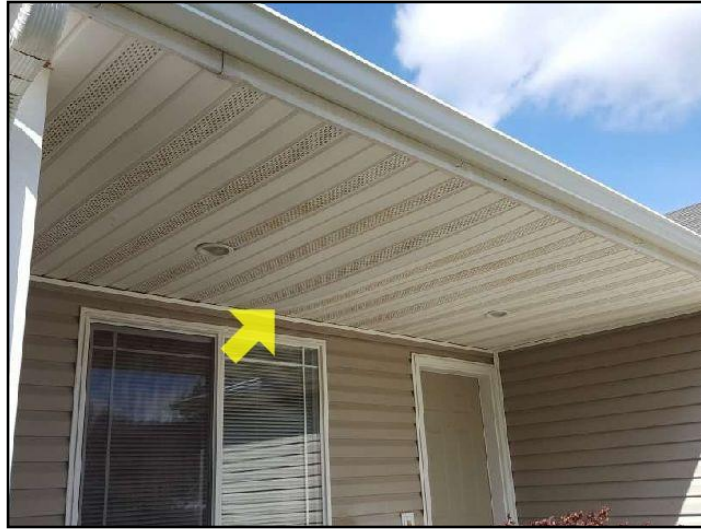
7. Condition: • [Loose or missing pieces](#)

Loose soffit trim

Task: Secure

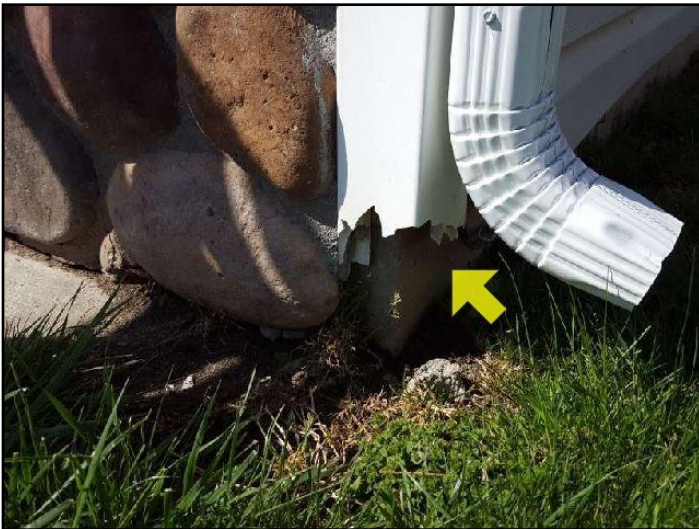
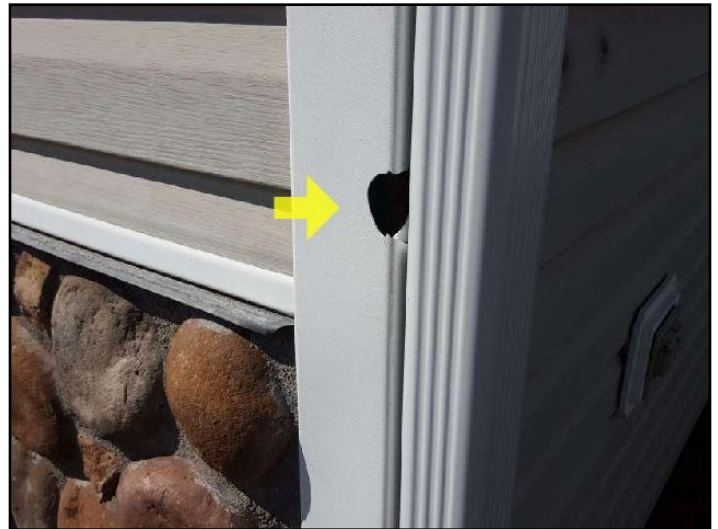
8. Condition: • Mechanical damage

Mechanical damage

Task: Repair

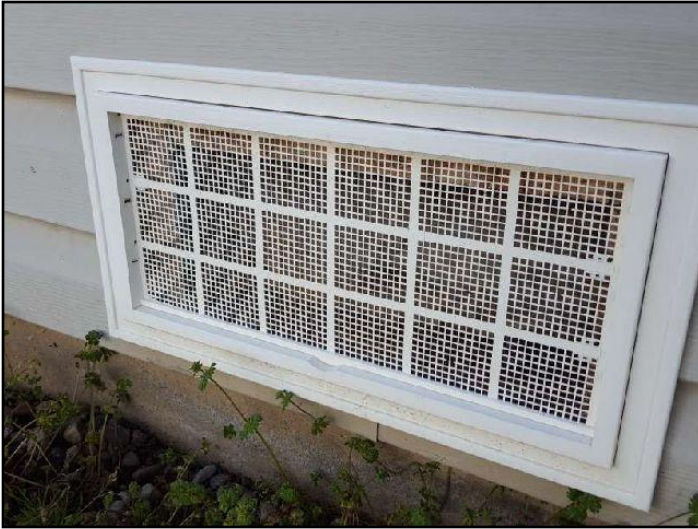
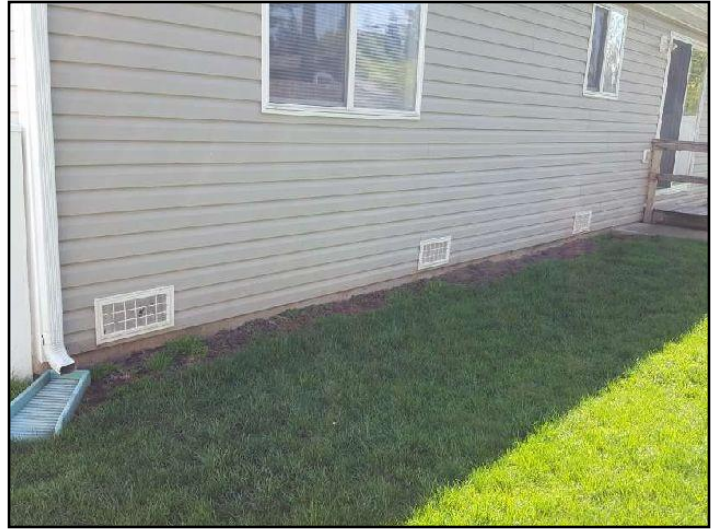
9. Condition: • Vent covers are missing for all 12 vents. Each vent should have three louvers that can be opened and closed.

Missing vent covers

Task: Provide covers

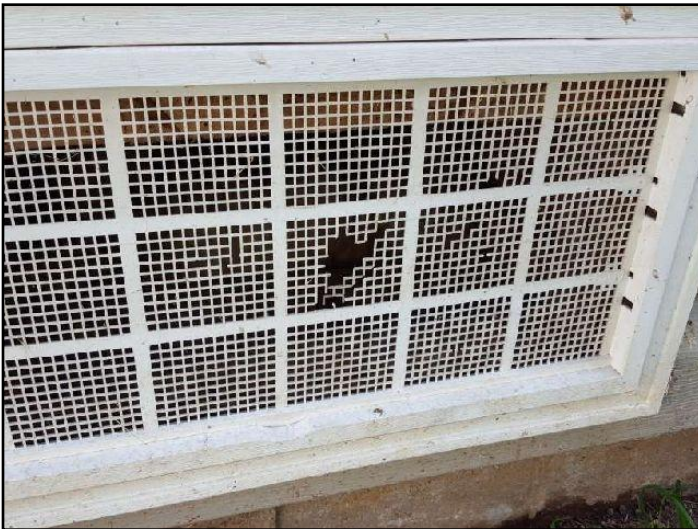
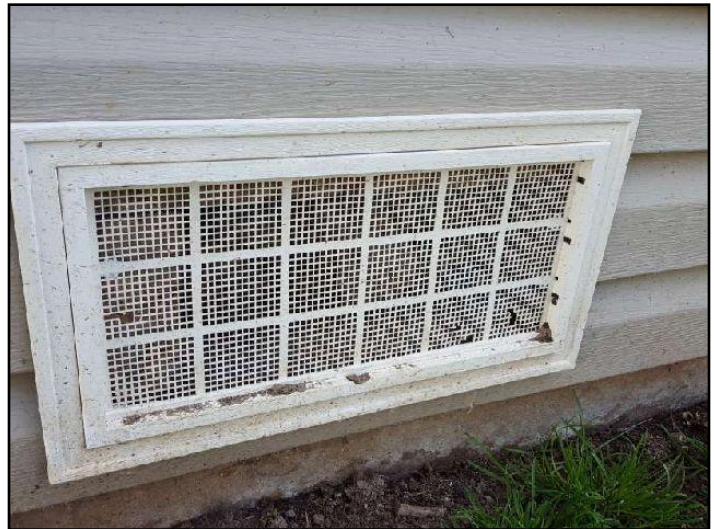
10. Condition: • Vent screens damaged

Vent screens damaged

Task: Repair or replace

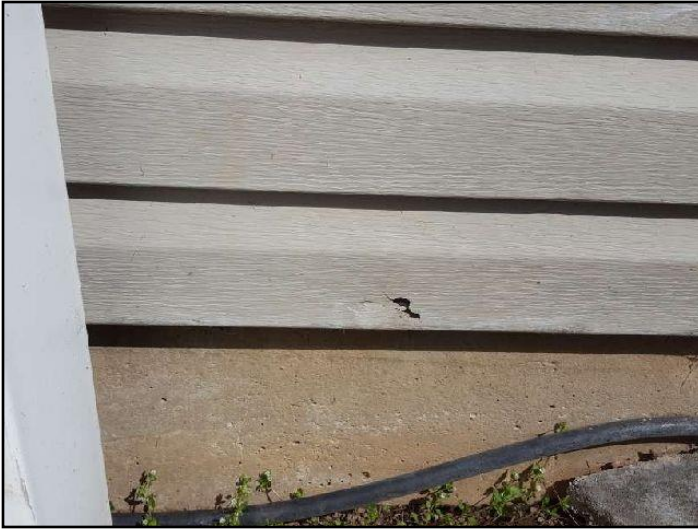
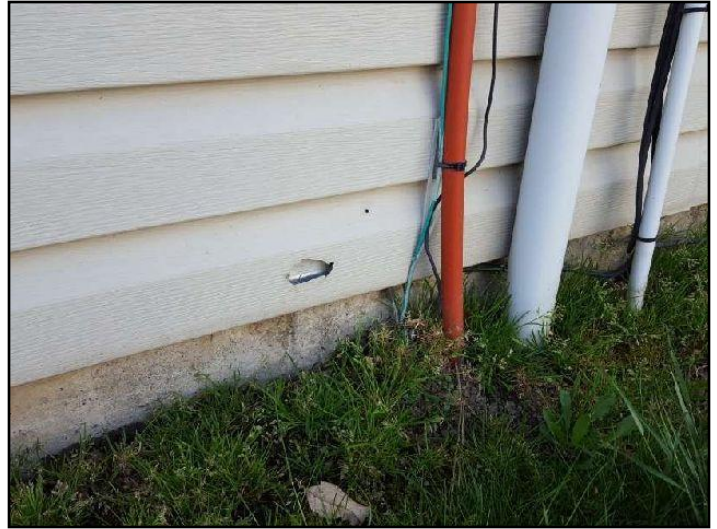
11. Condition: • [Mechanical damage](#)

Mechanical damage

Task: Repair

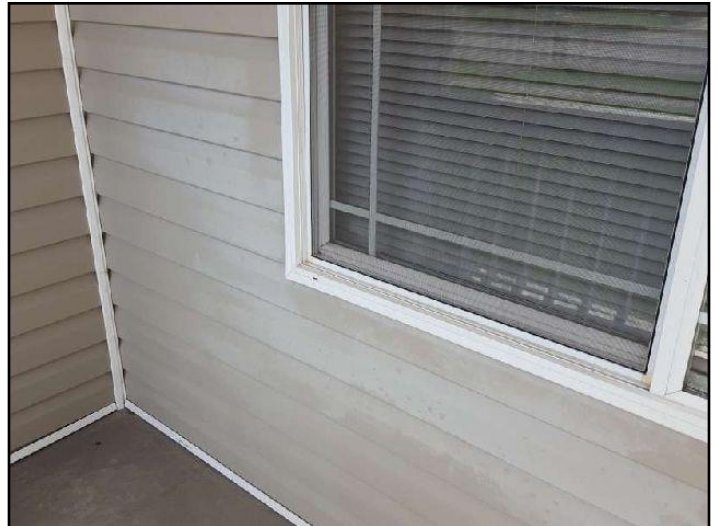
12. Condition: • [Discolored](#)

Discolored

Task: Treat/clean

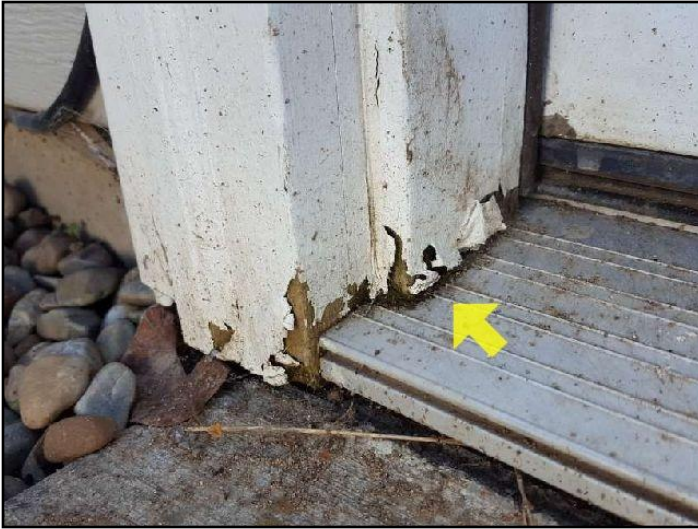
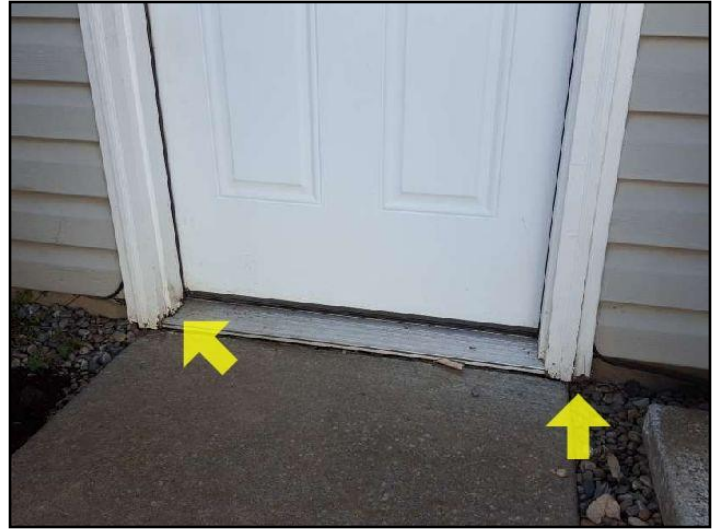
13. Condition: • Moisture damage

Moisture damage

Task: Dry trim and re-paint

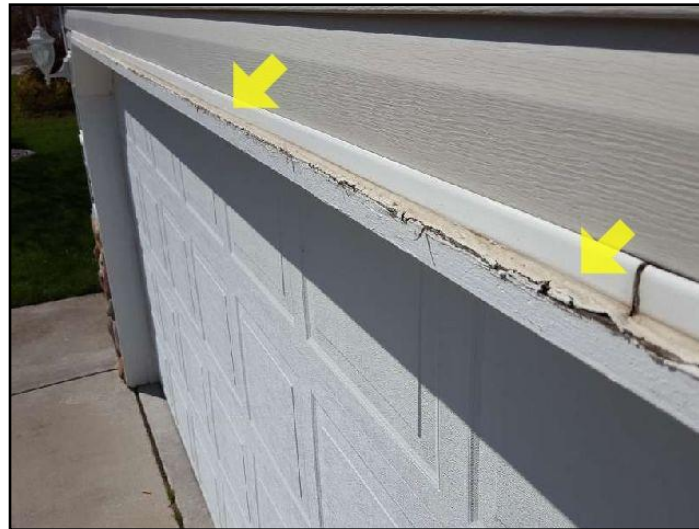
14. Condition: • [Paint or stain needed](#)

Paint needed

Task: Re-paint

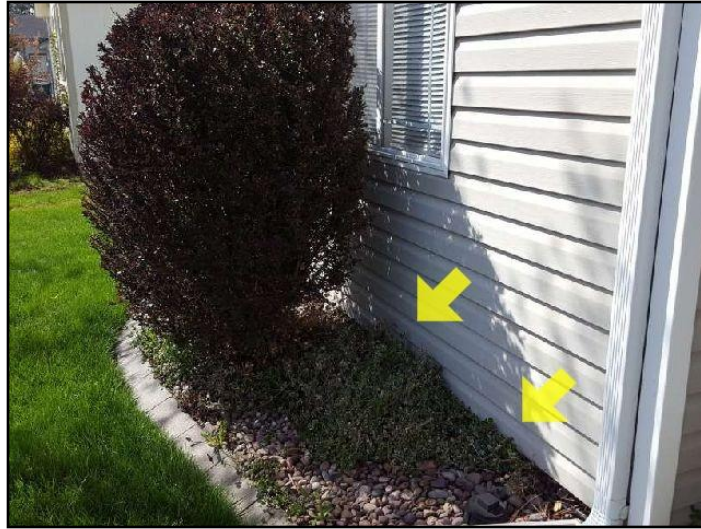
15. Condition: • [Trees or shrubs too close to building](#)

Shrubs too close to building

Task: Trim

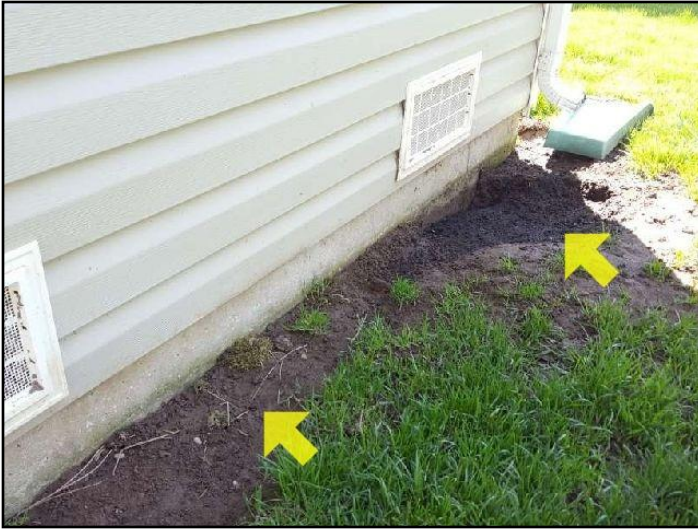
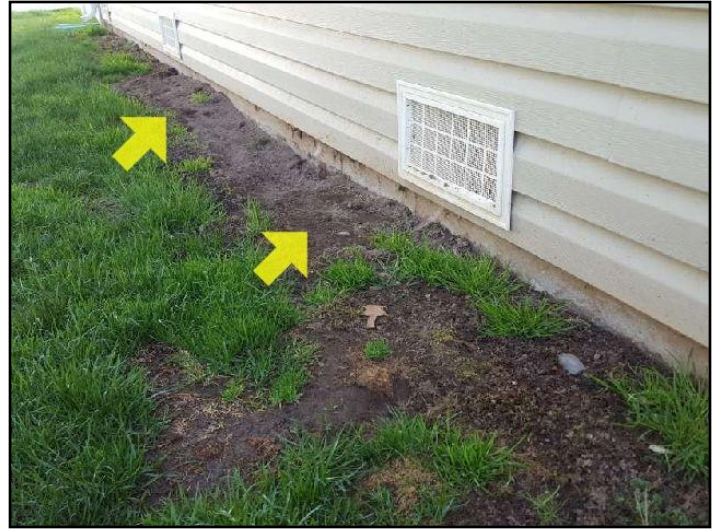
16. Condition: • [Improper slope or drainage](#)

Appears an animal has dug adjacent to the foundation

Improper slope or drainage

Task: Correct

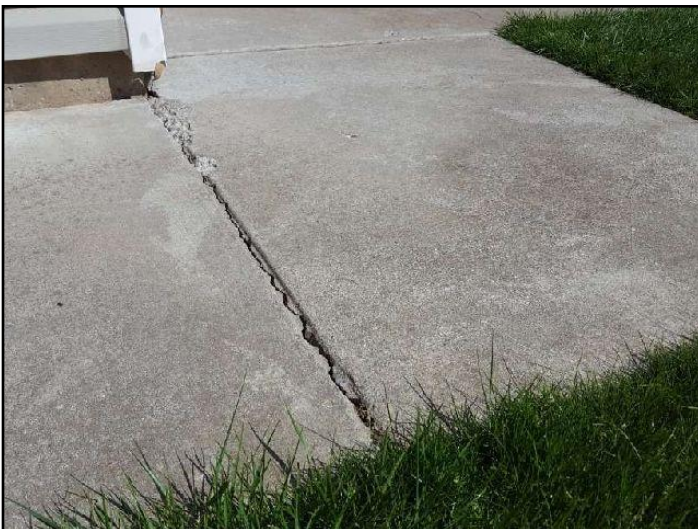
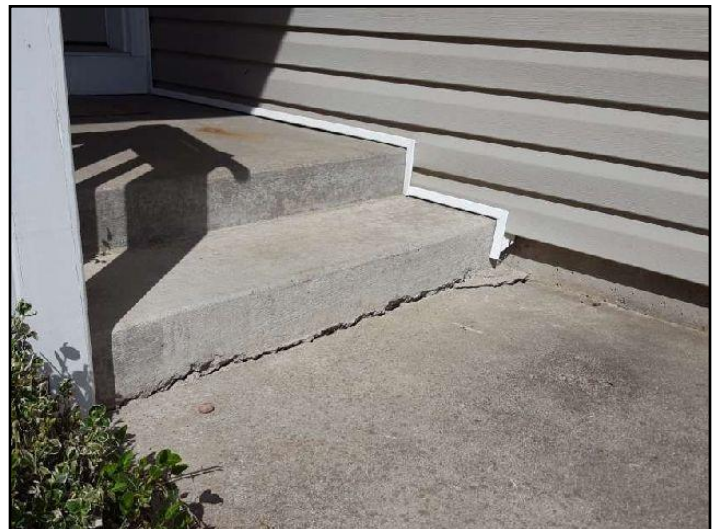
17. Condition: • [Cracked or damaged surfaces](#)

Cracked or damaged surfaces

Task: Monitor

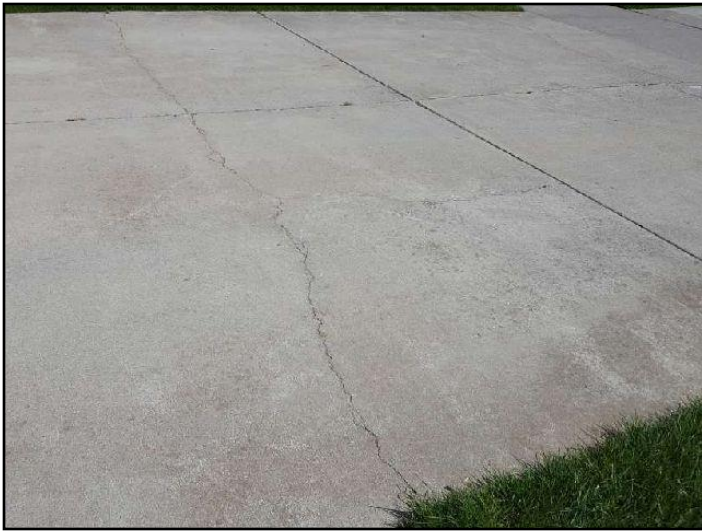
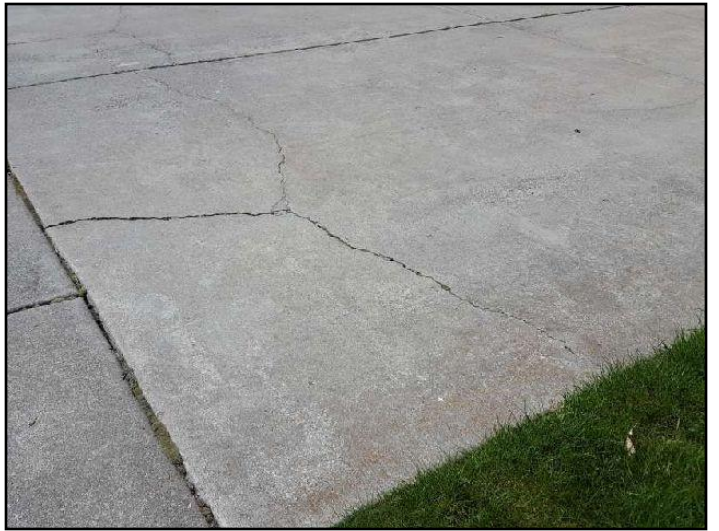
18. Condition: • [Cracked or damaged surfaces](#)

Cracked or damaged surfaces

Task: Monitor

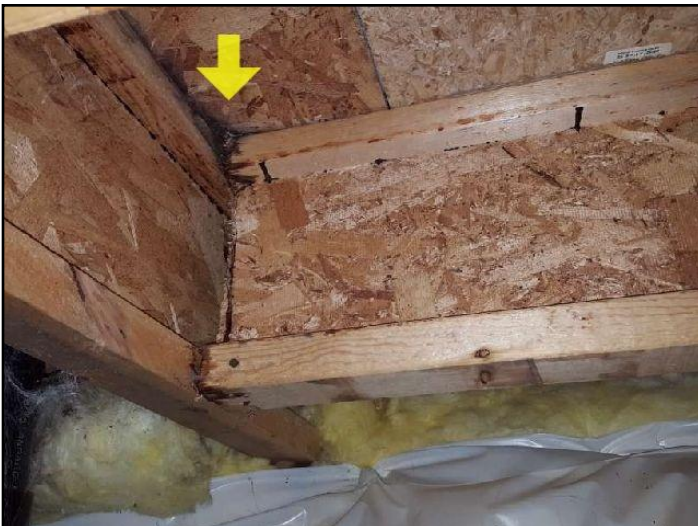
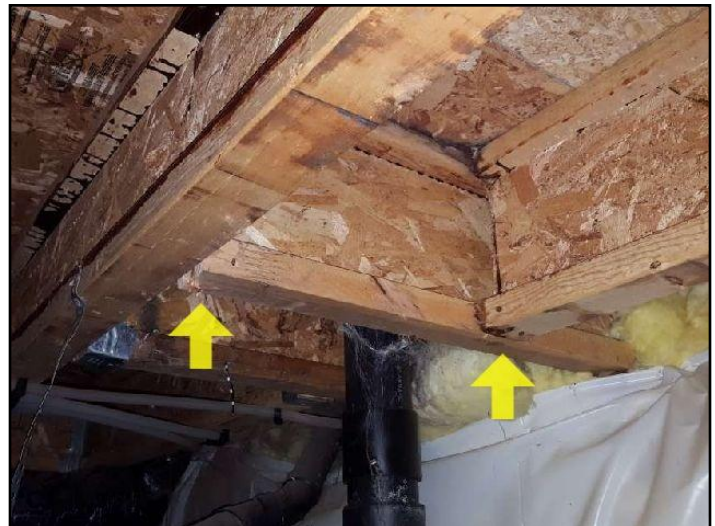
19. Condition: • [Poor end bearing, joist hanger connections](#)

Two joist hangers missing

Missing joist hanger

Missing joist hangers

Task: Install joist hangers

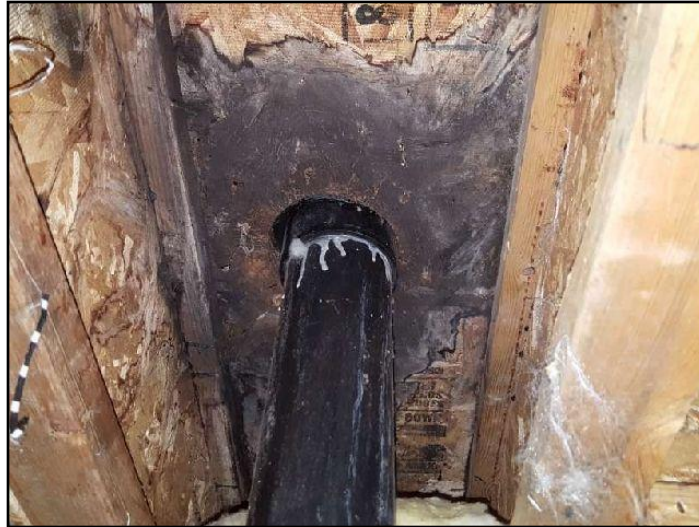
20. Condition: • Wood rot / moisture damage

Wood rot / moisture damage

Task: Remove and replace

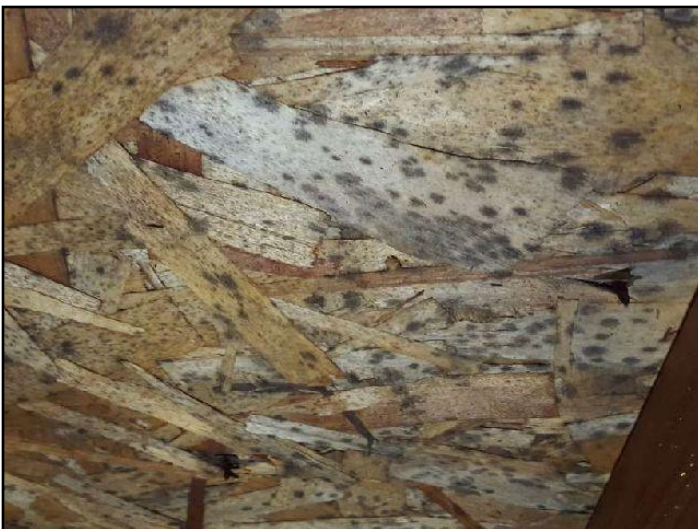
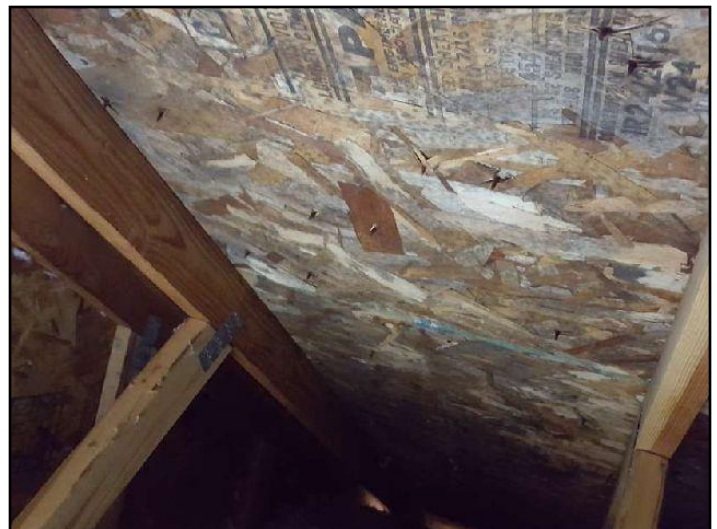
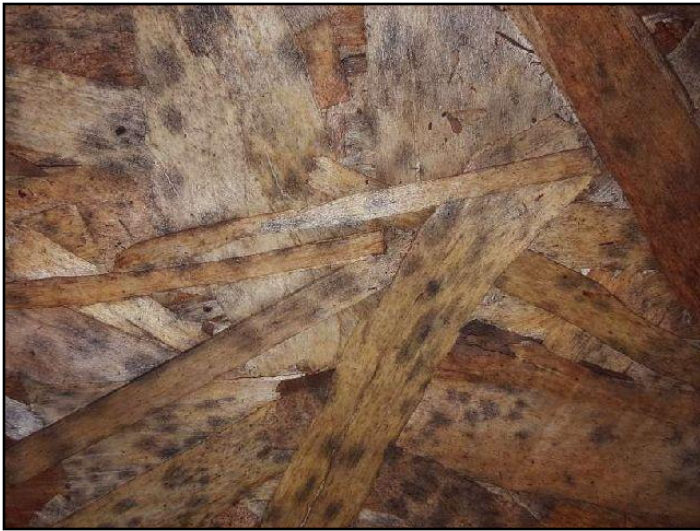
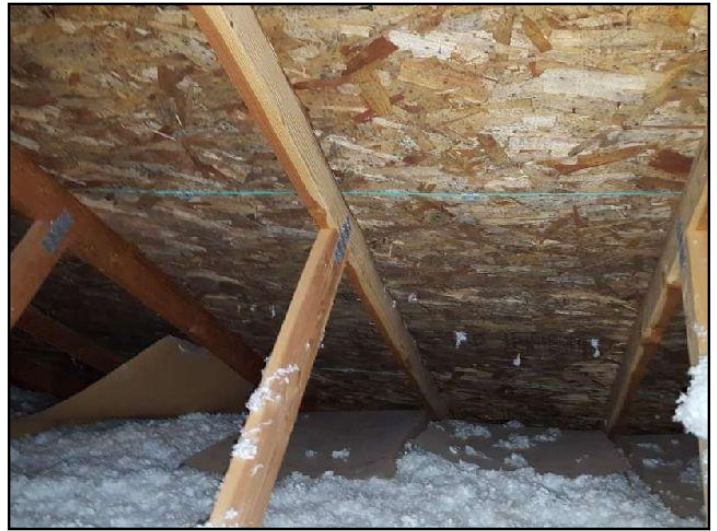
21. Condition: • Possible mold/mildew

Possible mold/mildew Possible mold/mildew

Possible mold/mildew

Task: Further evaluation by qualified mold remediation specialist

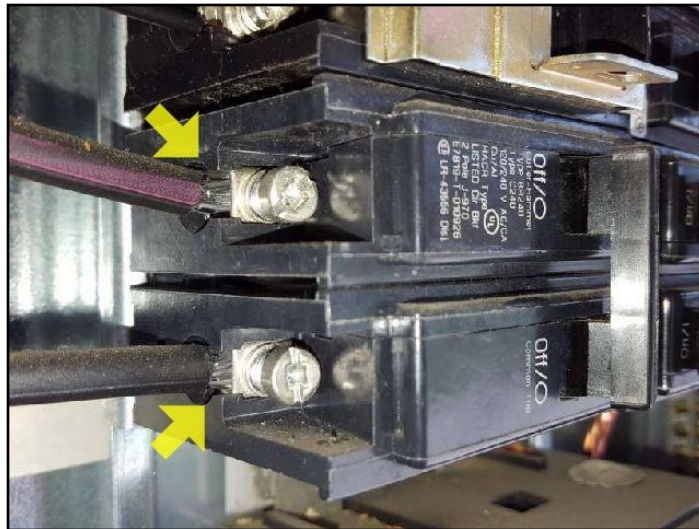
22. Condition: • [Anti-oxidant compound - missing](#)

Anti-oxidant compound - missing

Task: Apply anti-oxidant paste

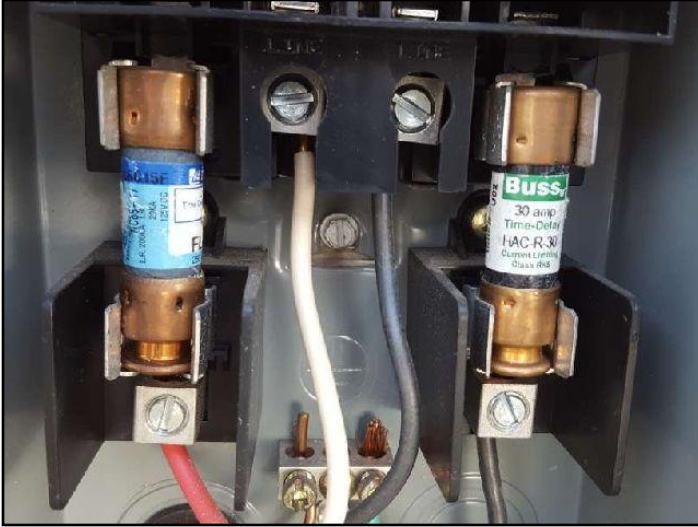
AC label indicates max 25-amp fuse/breaker. 30-amp fuses are installed.

29. **Condition:** • [Wrong fuse or breaker size](#)

30-amp fuses installed

Task: Replace fuses

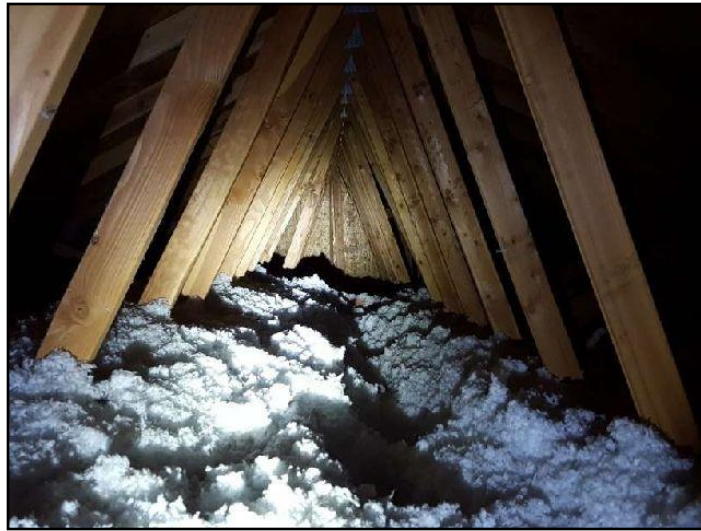
31. Condition: • [Compressed](#)

Foot traffic has compressed insulation

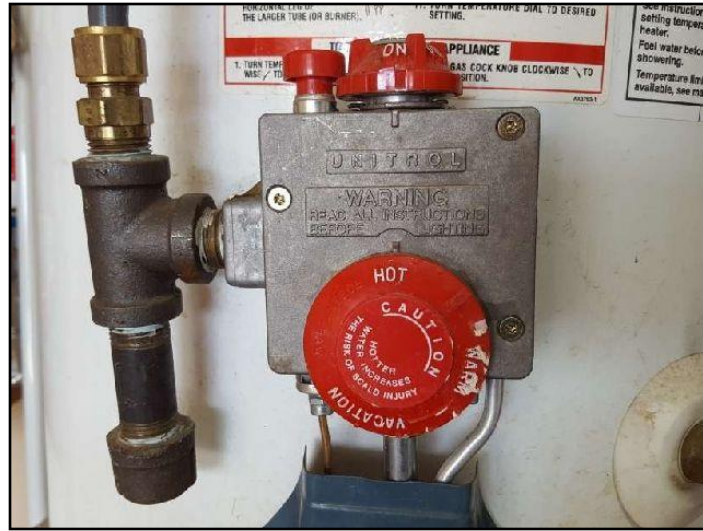
32. Condition: • [Water temperature is above the desired 115 - 125 degree range.](#)
140 degrees

Task: Adjust thermostat

Adjust thermostat

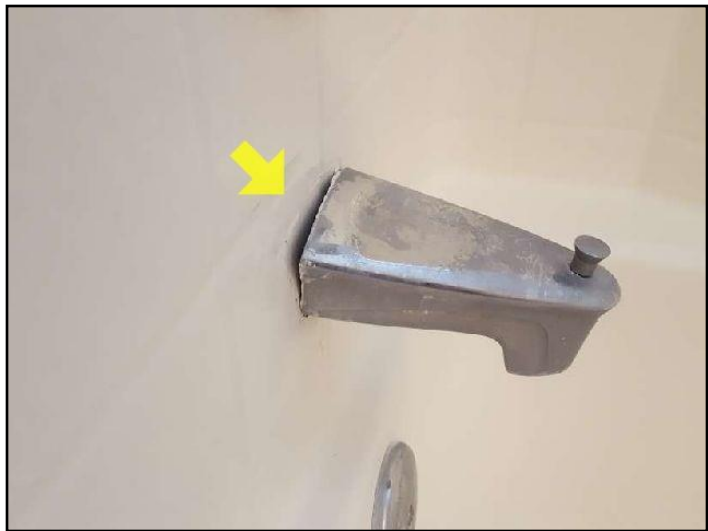
35. Condition: • Tub faucet bent downward and separated from shower wall

Faucet bent and separated

Task: Improve

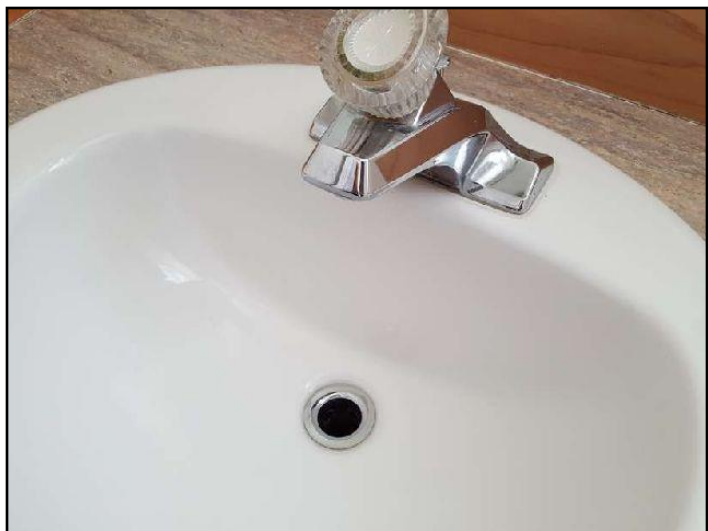
36. Condition: • Drain stop missing

Drain stop missing

Task: Improve

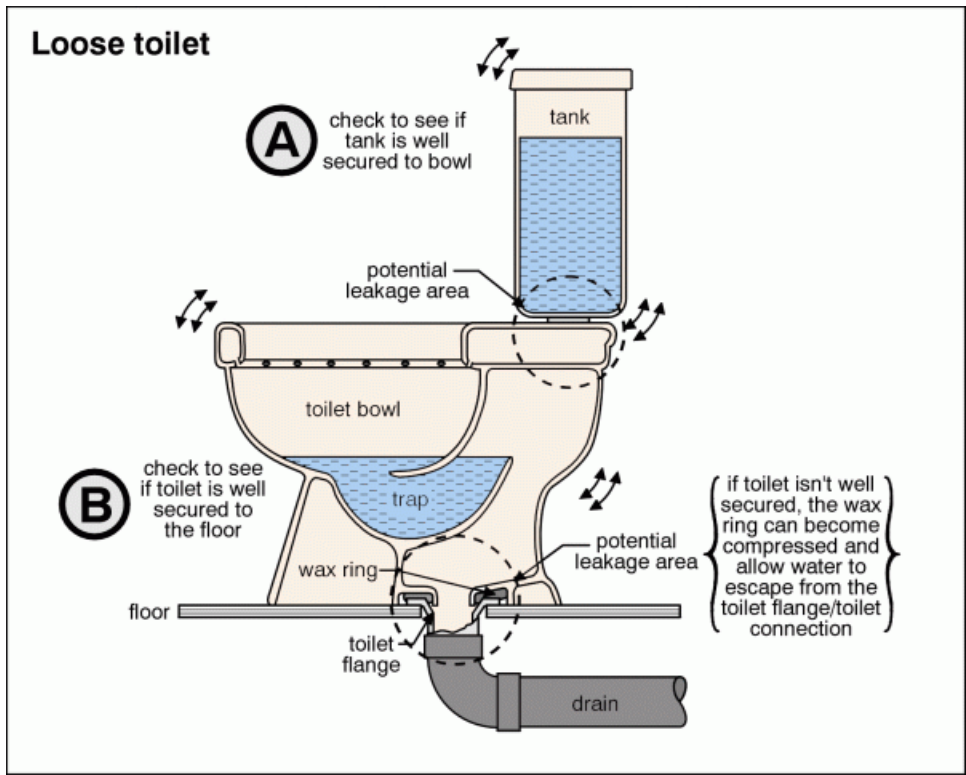
37. Condition: • [Loose](#)

Toilets are loose at the floor

Task: Correct

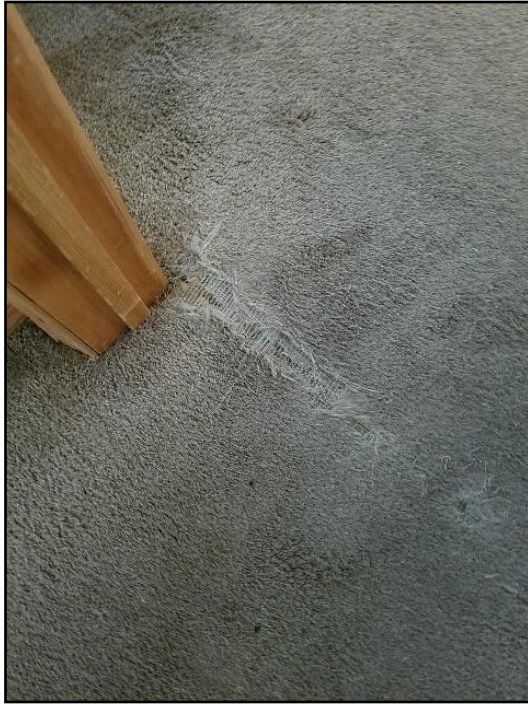
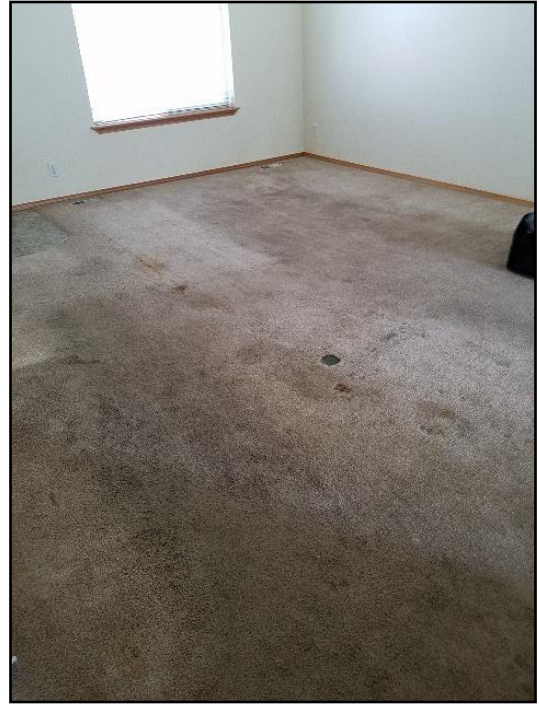
38. Condition: • Torn, damaged carpet. Severely stained carpet.

Torn carpet

Stained carpet

Task: Replace

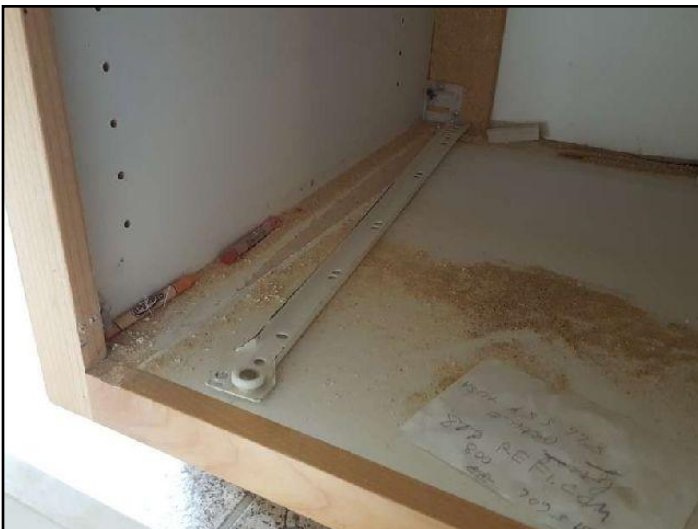
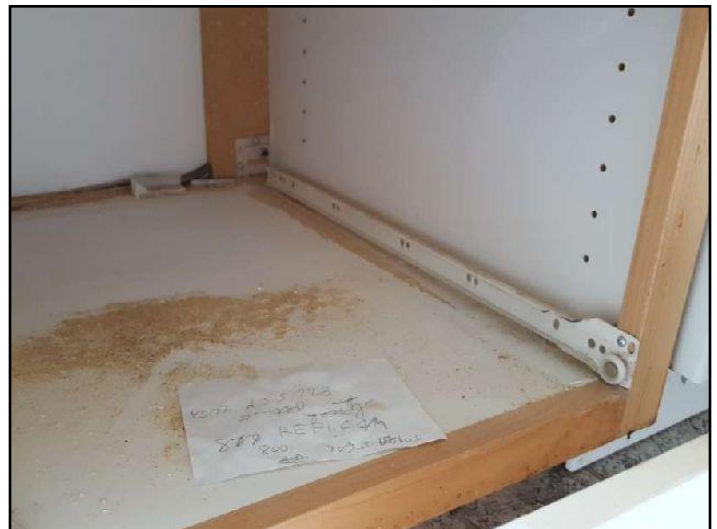
39. Condition: • [Stiff or inoperative drawers](#)

Broken drawer hardware

Task: Repair

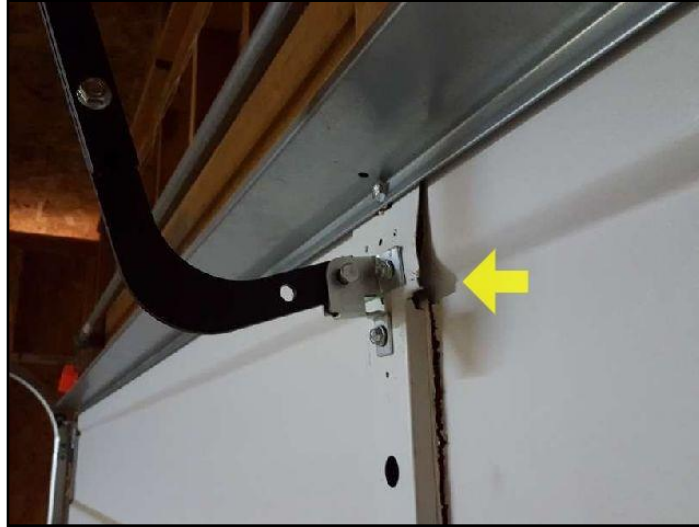
40. Condition: • Bracket attachment damaged

Bracket attachment damaged

Task: Repair

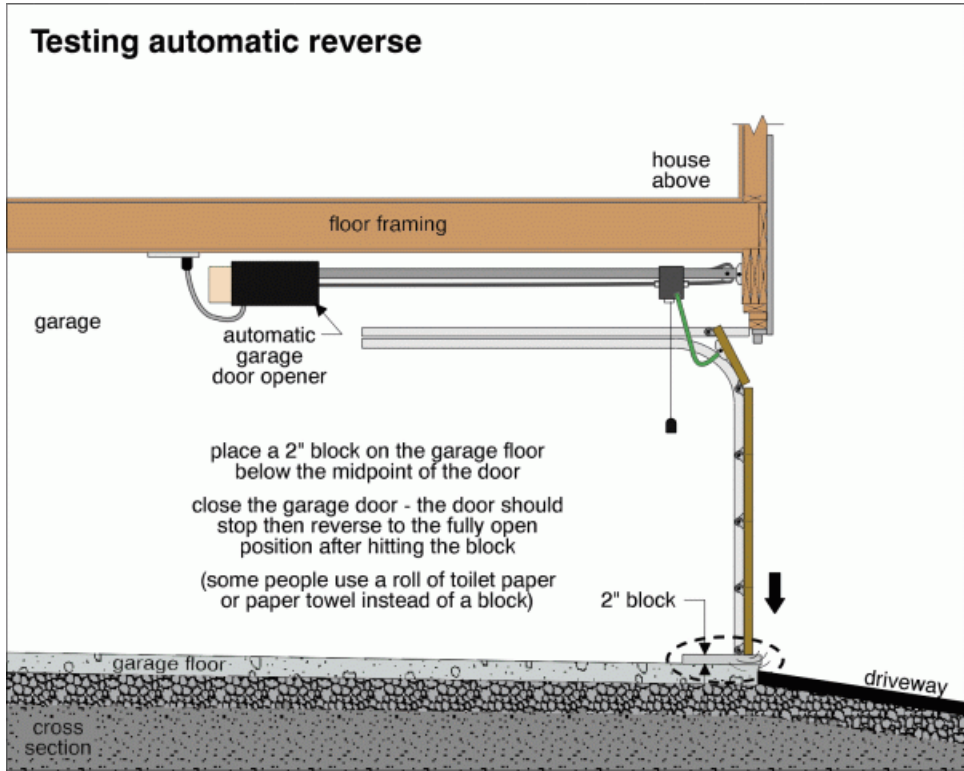
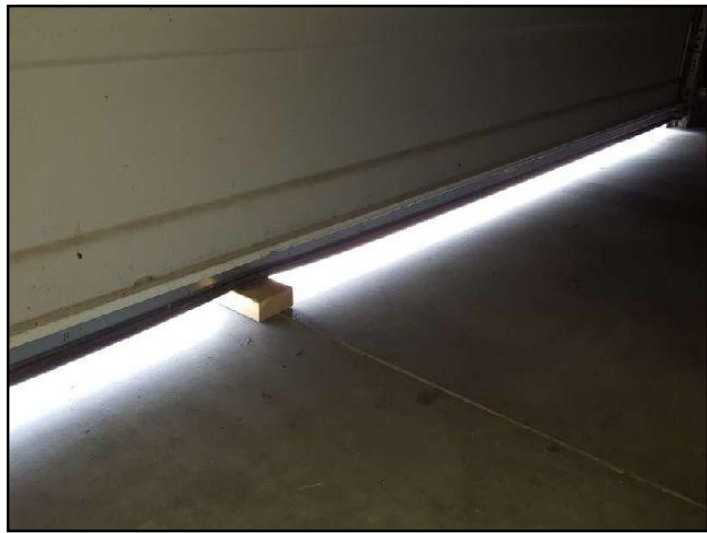
41. Condition: • [Fails to auto reverse](#)

Fails to auto reverse when closing on a 2-inch block. Photoelectric eye safety function is operational.

Fails to auto reverse

Task: Adjust opener
