Your Inspection Report

1371 Elderberry Circle
Coeur d'Alene, ID 83815

INSPECTION DATE:
Monday, April 30, 2018

RE: Report No. 1219
1371 Elderberry Circle
Coeur d'Alene, ID
83815

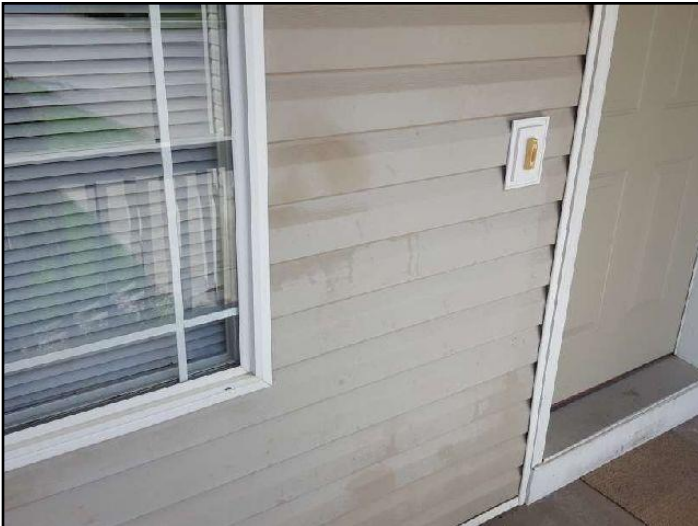
12. Condition: • [Discolored](#)

Discolored

Task: Treat/clean

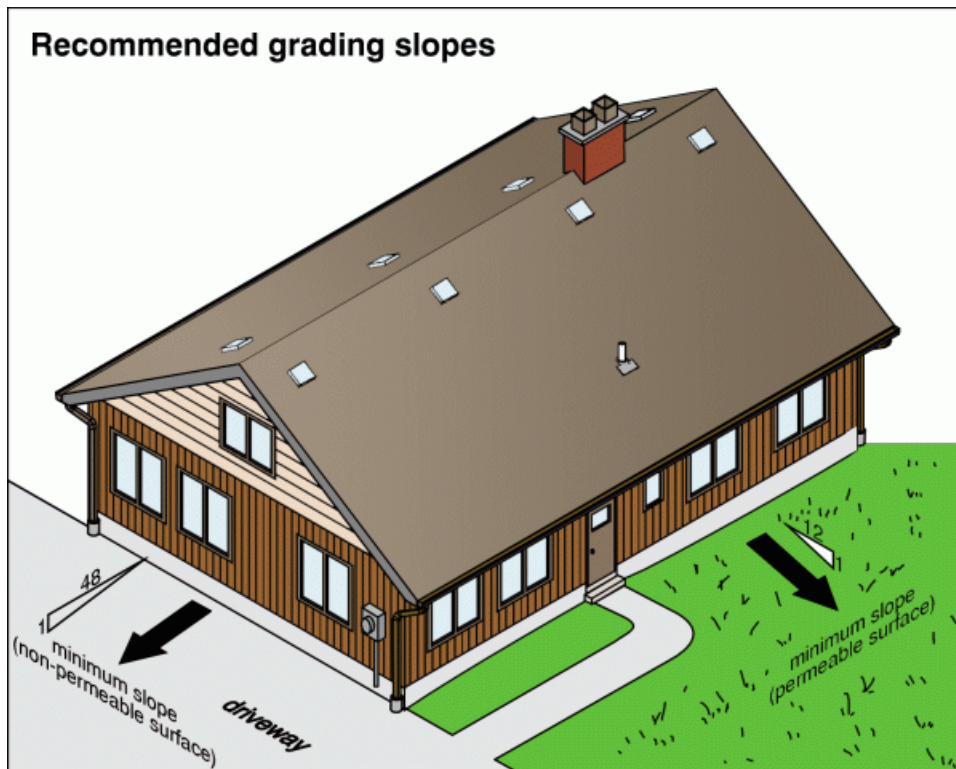
16. Condition: • [Improper slope or drainage](#)

Appears an animal has dug adjacent to the foundation

Implication(s): Chance of water damage to contents, finishes and/or structure

Task: Correct
